Collaboration in Conservation Chichester Festival Theatre: a case study

15th June 2018

Chichester Festival Theatre: a case study

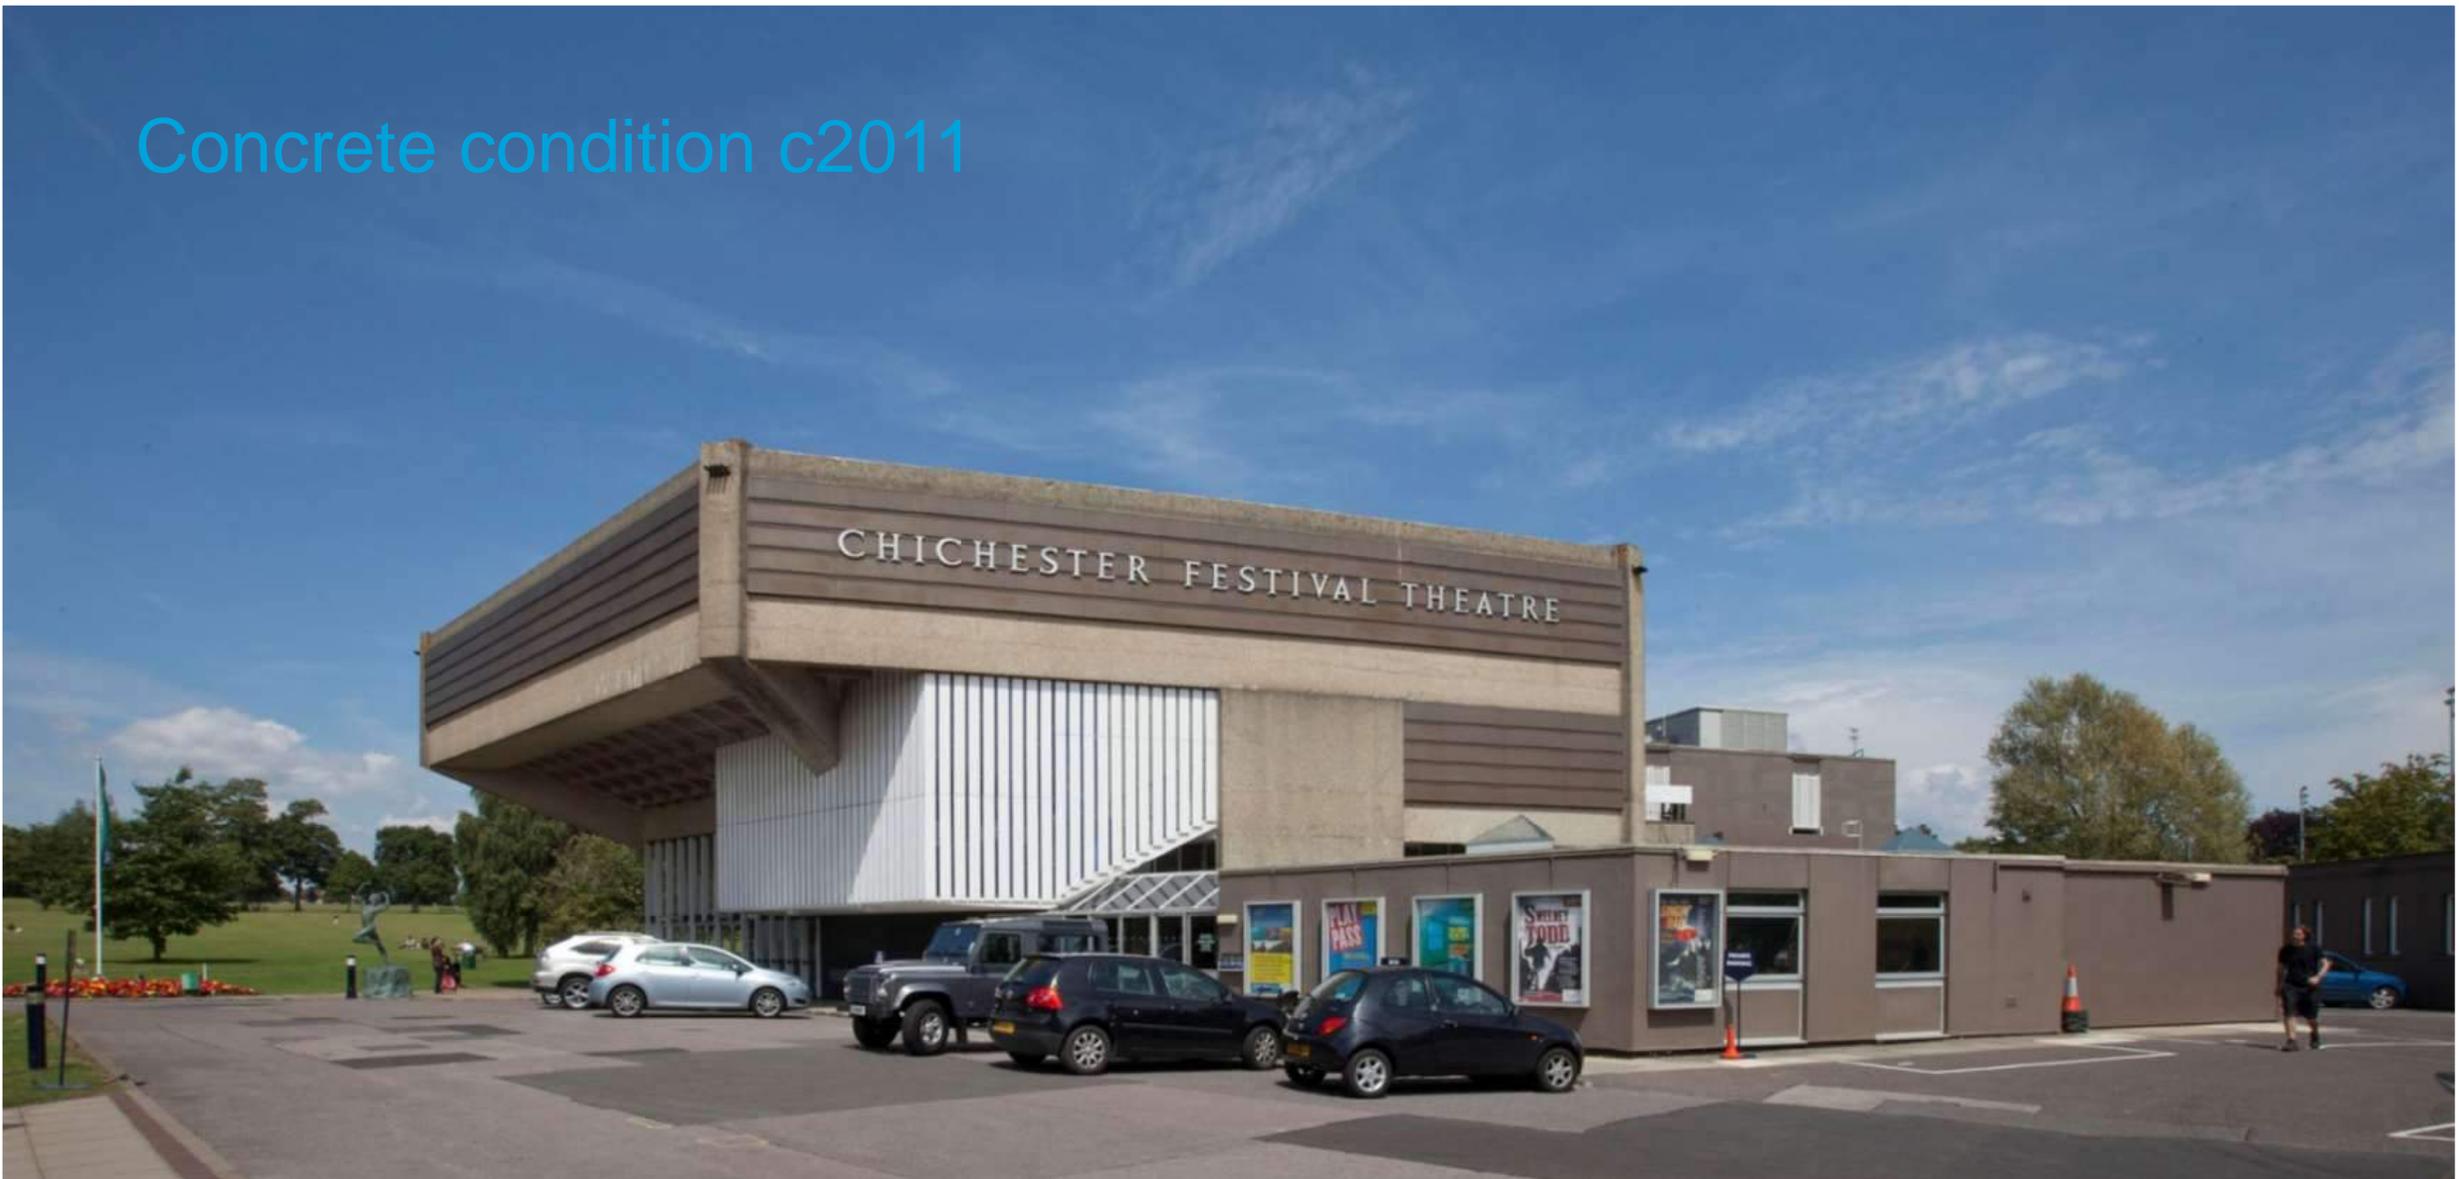
Concrete condition c2011

At several areas, in particular the westerly facing gallery beams, the **cover** to the concrete is very low and the **carbonation** front has caused **steel corrosion** and **spalling** of the concrete. These and other external faces identified will need to undergo some remedial works to restore the appearance of the theatre building and to prevent any further deterioration (2011, Concrete Condition Survey).

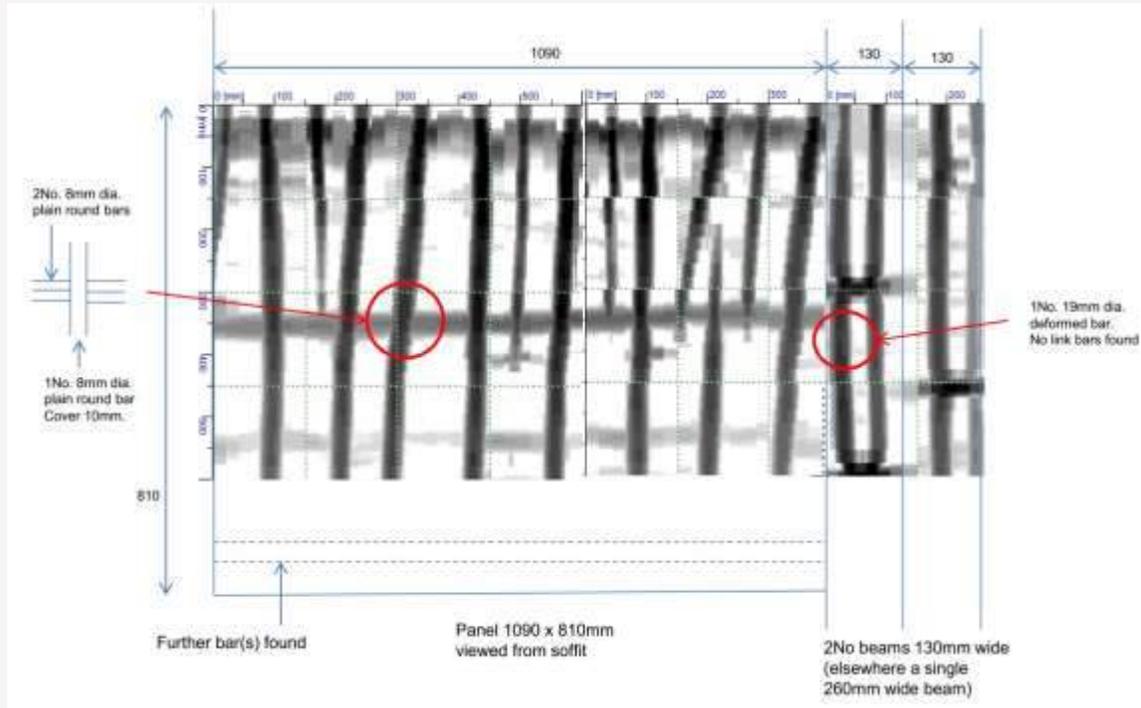
Concrete condition c2011

Core No.	Location	Density (Kg/m ³)	Compressive Strength (N/mm ²)
Loc 1	Internal horizontal beam at back of stage	2280	50.7
Loc 2	Internal horizontal beam at back of stage	2270	49.8
Loc 3	External beam (suggested trial area)	2260	49.4
Loc 4	External beam (suggested trial area)	Microscopic Examination	
C1	Elevation 1-6 Gallery beam side	Microscopic Examination	
C2	Elevation 6-5 Wall	Not extracted - excessive steel encountered during drilling	
C3	Elevation 2-1 Gallery beam side	2300	58.4
C4	Elevation 2-1 Gutter beam	2290	54.6
C5	Elevation 3-2 Lower beam	2290	50

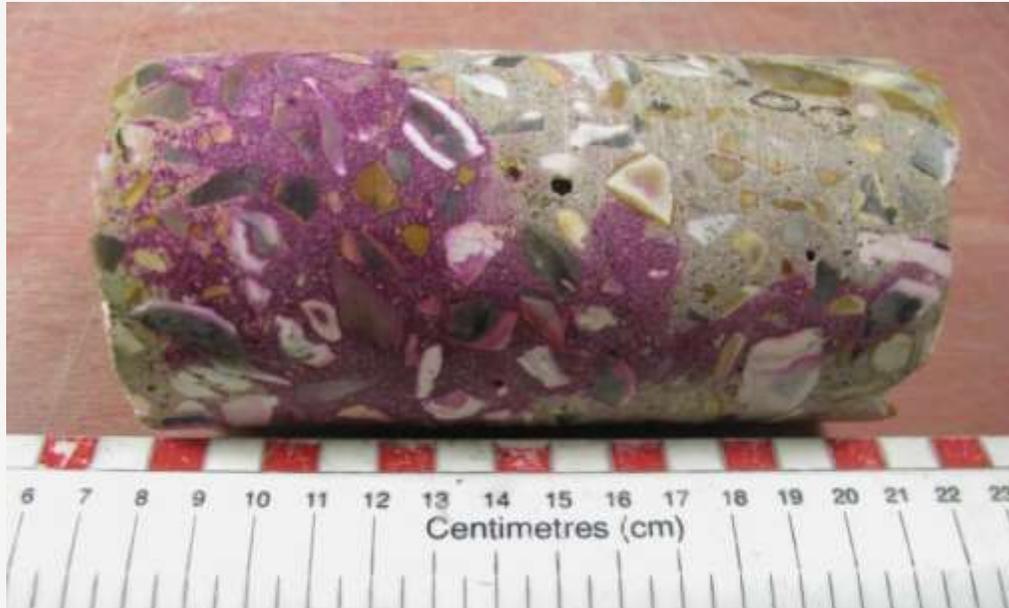
Concrete condition c2011

There is a simple “rule of thumb” that can be used to determine the expected depth of **carbonation** of good quality concrete: the depth of carbonation in mm should roughly equal the square root of the age of the structure in years.

Concrete used in the construction of the theatre is of **variable quality**, based on the depths of carbonation observed (less than 1mm up to 30mm).

Depths of carbonation significantly exceeding this criterion were found in about one third of the areas examined.
