Collaboration in Conservation Chichester Festival Theatre: a case study

15th June 2018

Chichester Festival Theatre: a case study

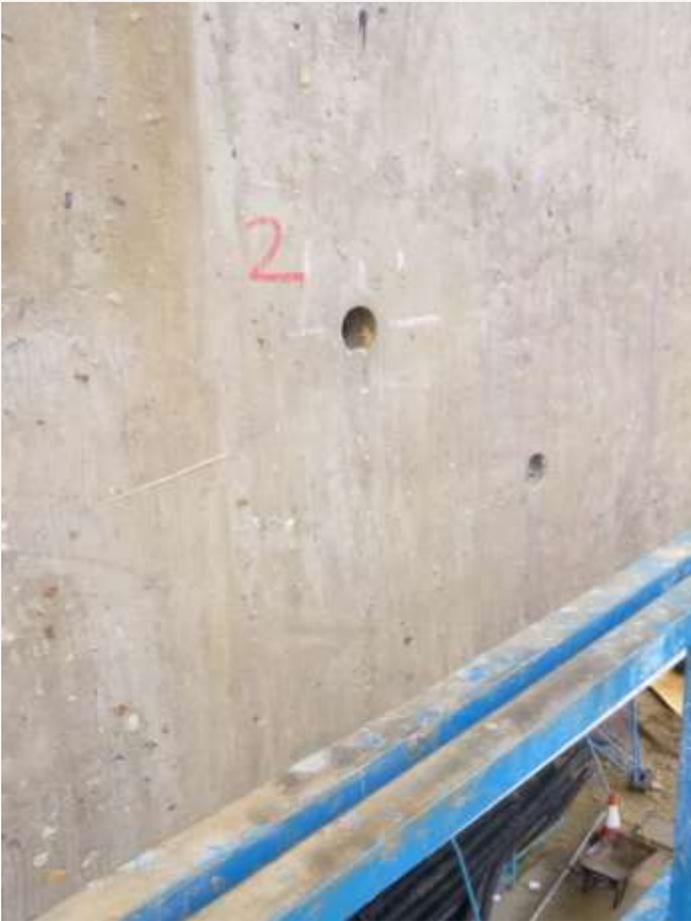
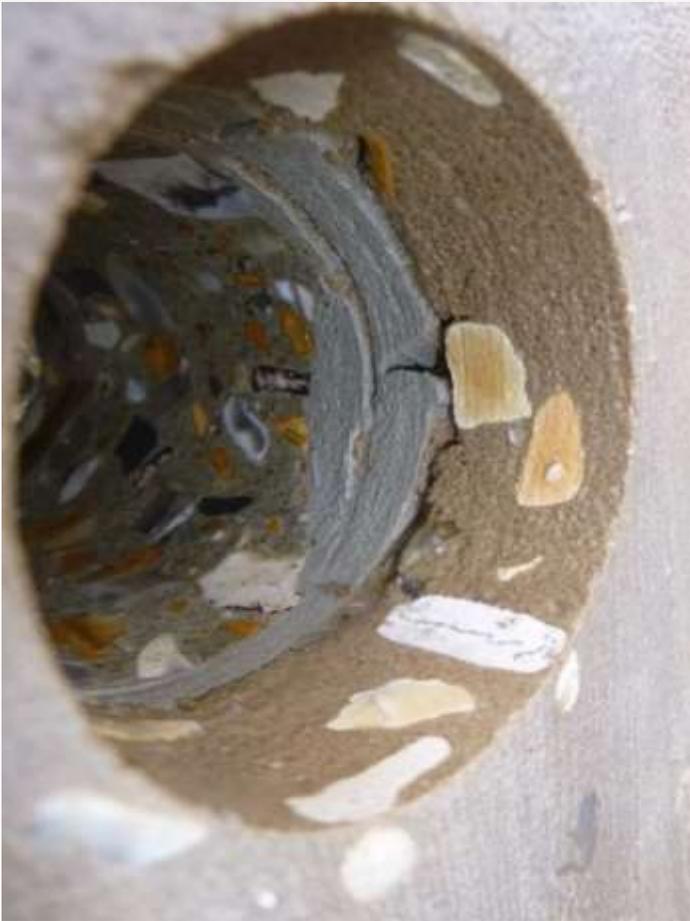
Testing of concrete repair

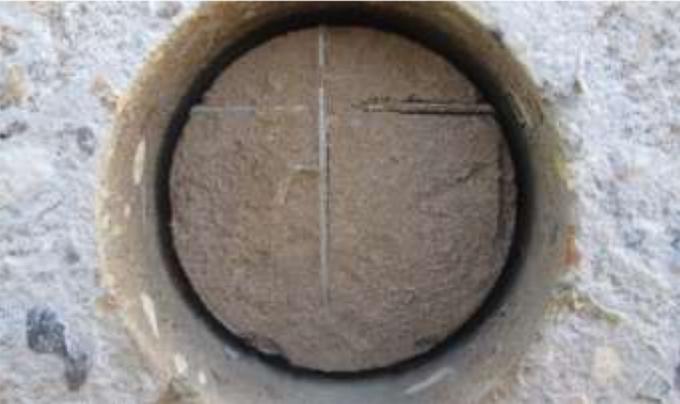
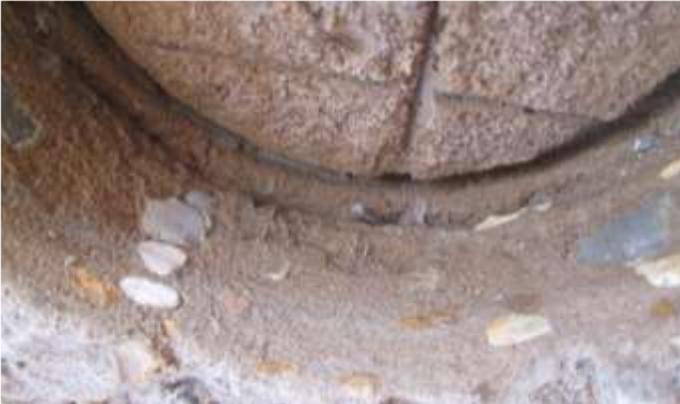
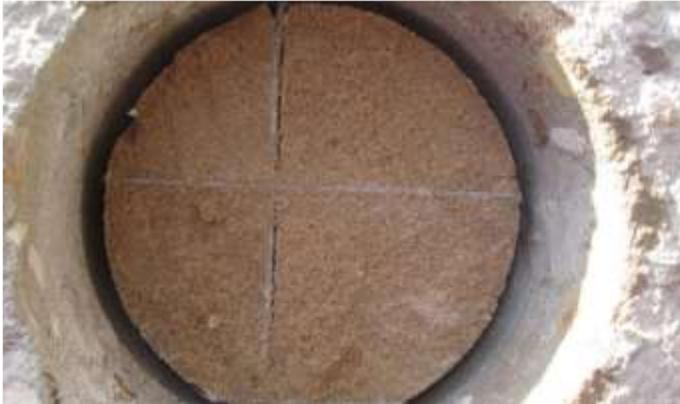
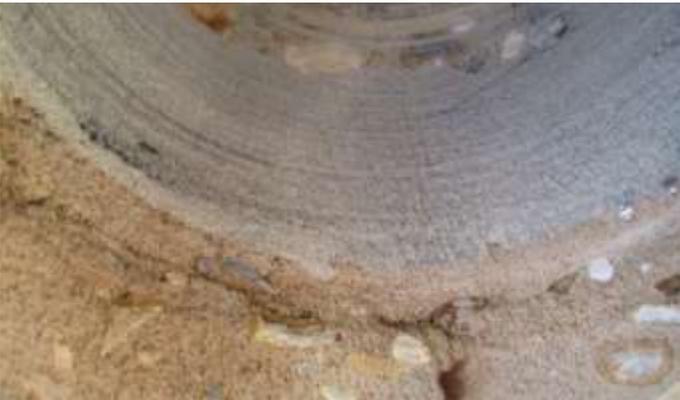
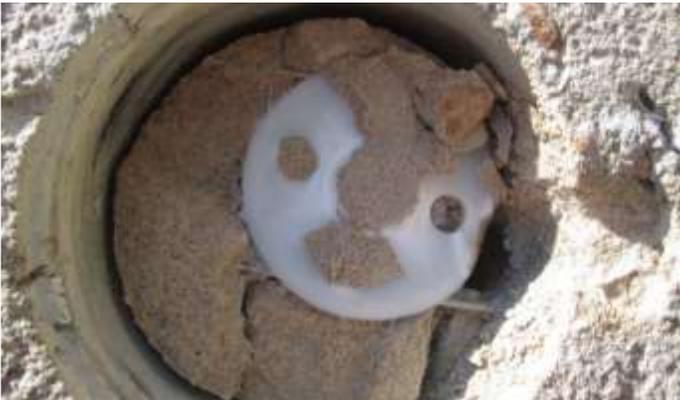
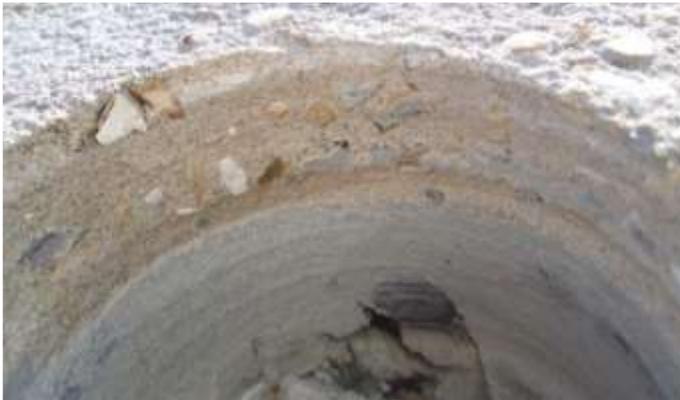
Testing of concrete repair (application two)

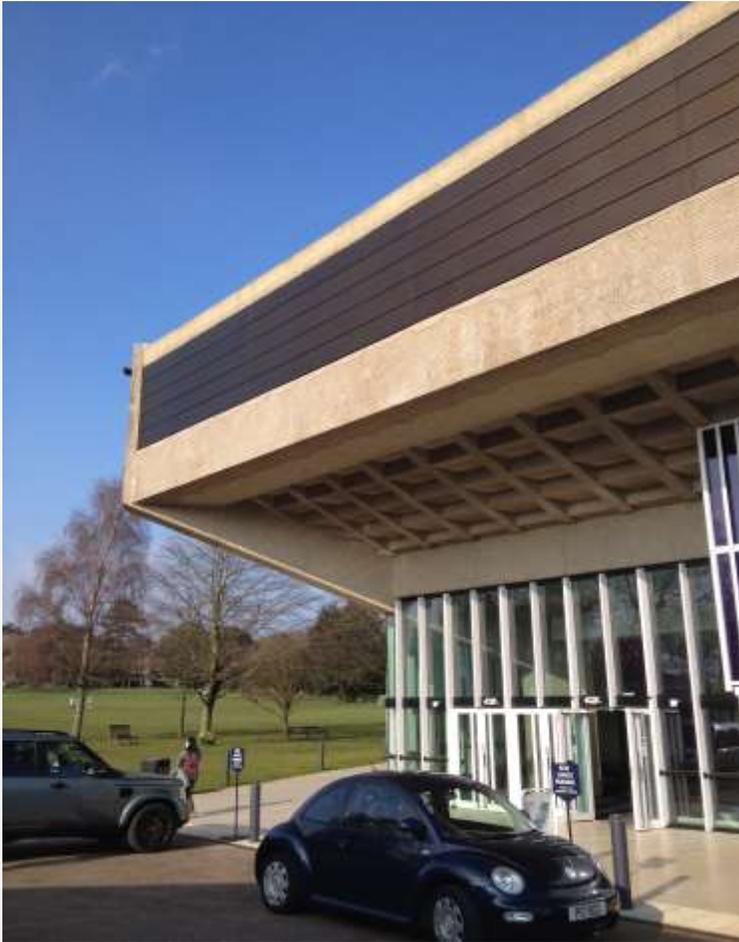
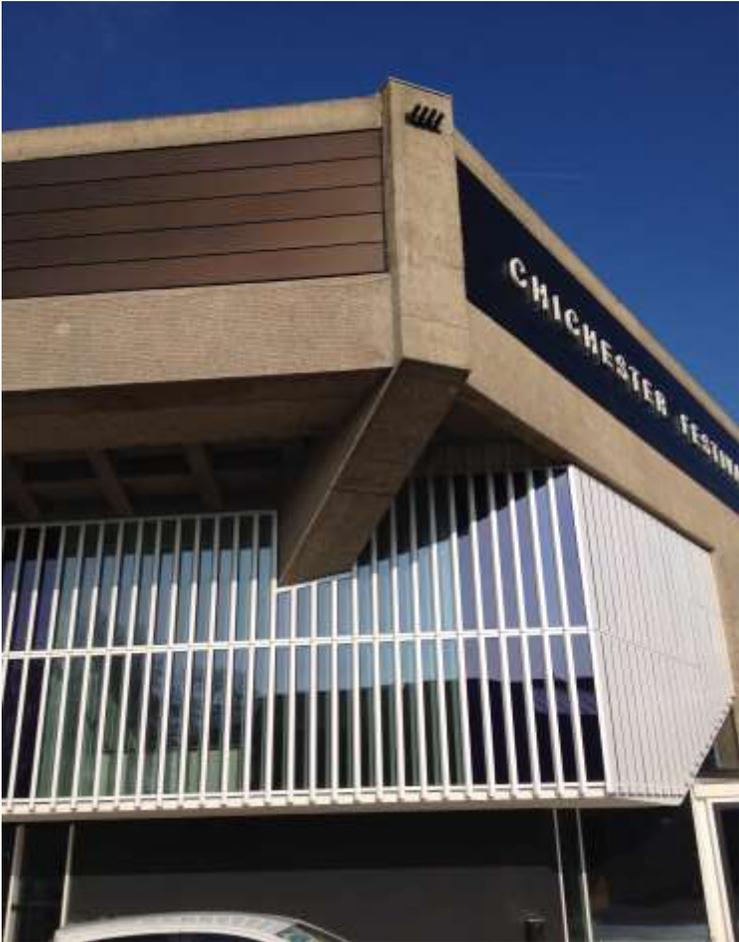
Temporary measures

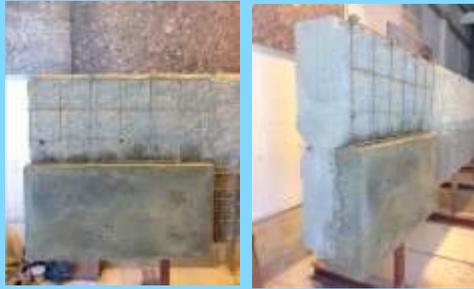
Fig.1 First panel. N.b. tide mark and difference in colouration

Unevenness within the panel was identified and this was found to be due to the formwork and number and positioning of fixings.

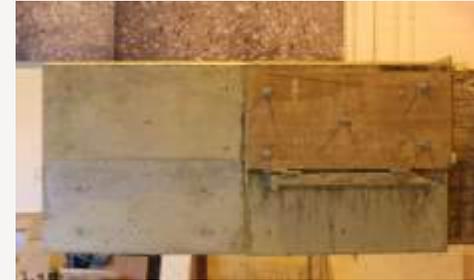
Fig.1 Panels 1-4 with shuttering in situ on panel 4

There was cracking noted to the surface of the concrete where the formwork had been overtightened after the concrete had started to cure. A larger 'polypipe' sleeve was used compared to the first panel.

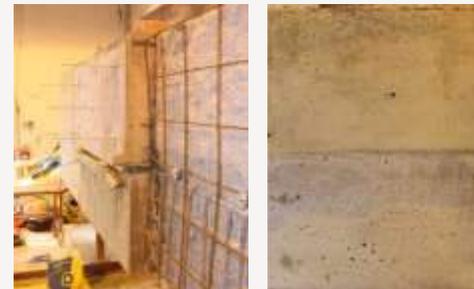
Fig.2 Oblique view of cast panels

Fig.3 Close up of day joint between panels 1 and 2

The horizontal joint between panels was deemed to be good with the exception of deflection found within the formwork.

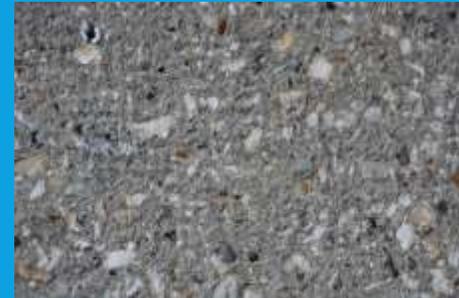
Fig.2 A close up of the internal concrete at CFT. A repetitive patterning is visible, suggestive of a percussive form of finishing

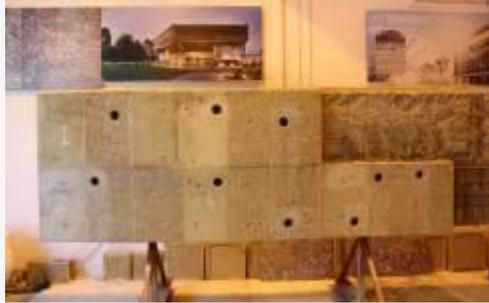
Fig.1 Core testing carried out to applied panels

75mm diameter cores were taken. The cores and corresponding holes were inspected for voiding, cracking and general structural integrity. Almost all of the cores exhibited good compaction of the concrete through its full thickness, with little or no voiding in most areas.

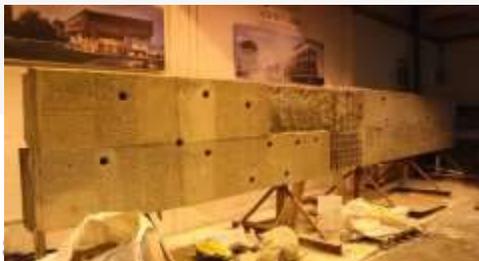
Fig.2 Additional cores were taken to determine the quality and bond between panels

The cores were also used for pull-off tests to check the adherence of the repair panels to the parent concrete. Unfortunately, due to the nature of the build up of the repair panels with the new and existing steel reinforcement, many of the cores delaminated during the coring process. Those that were able to be pulled off returned relatively low results for adherence. This was thought to be attributable to the damage caused by the coring process.

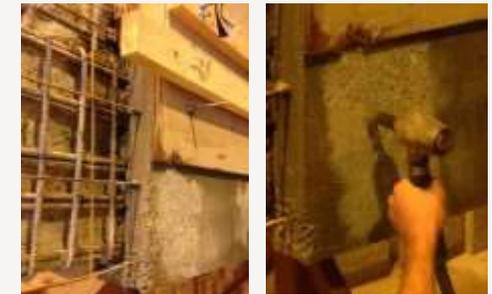
Fig.2 Corner of panel six illustrating voiding caused by run off of water from mix

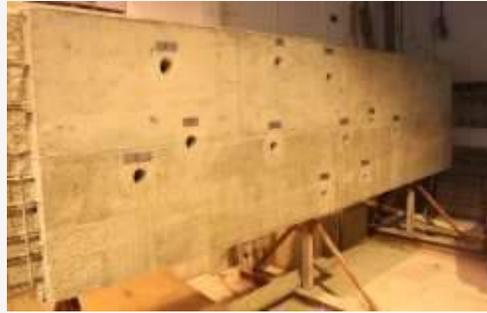
Fig.1 Core testing of panels six and seven

Physical tests were carried out as per 'Experiment Activity: Ten'. Results demonstrated that there was minimal voiding within those cores tested and that results were consistent with those found in earlier panels. The increase in panel size has not led to any concerns of problems being identified by testing performed.

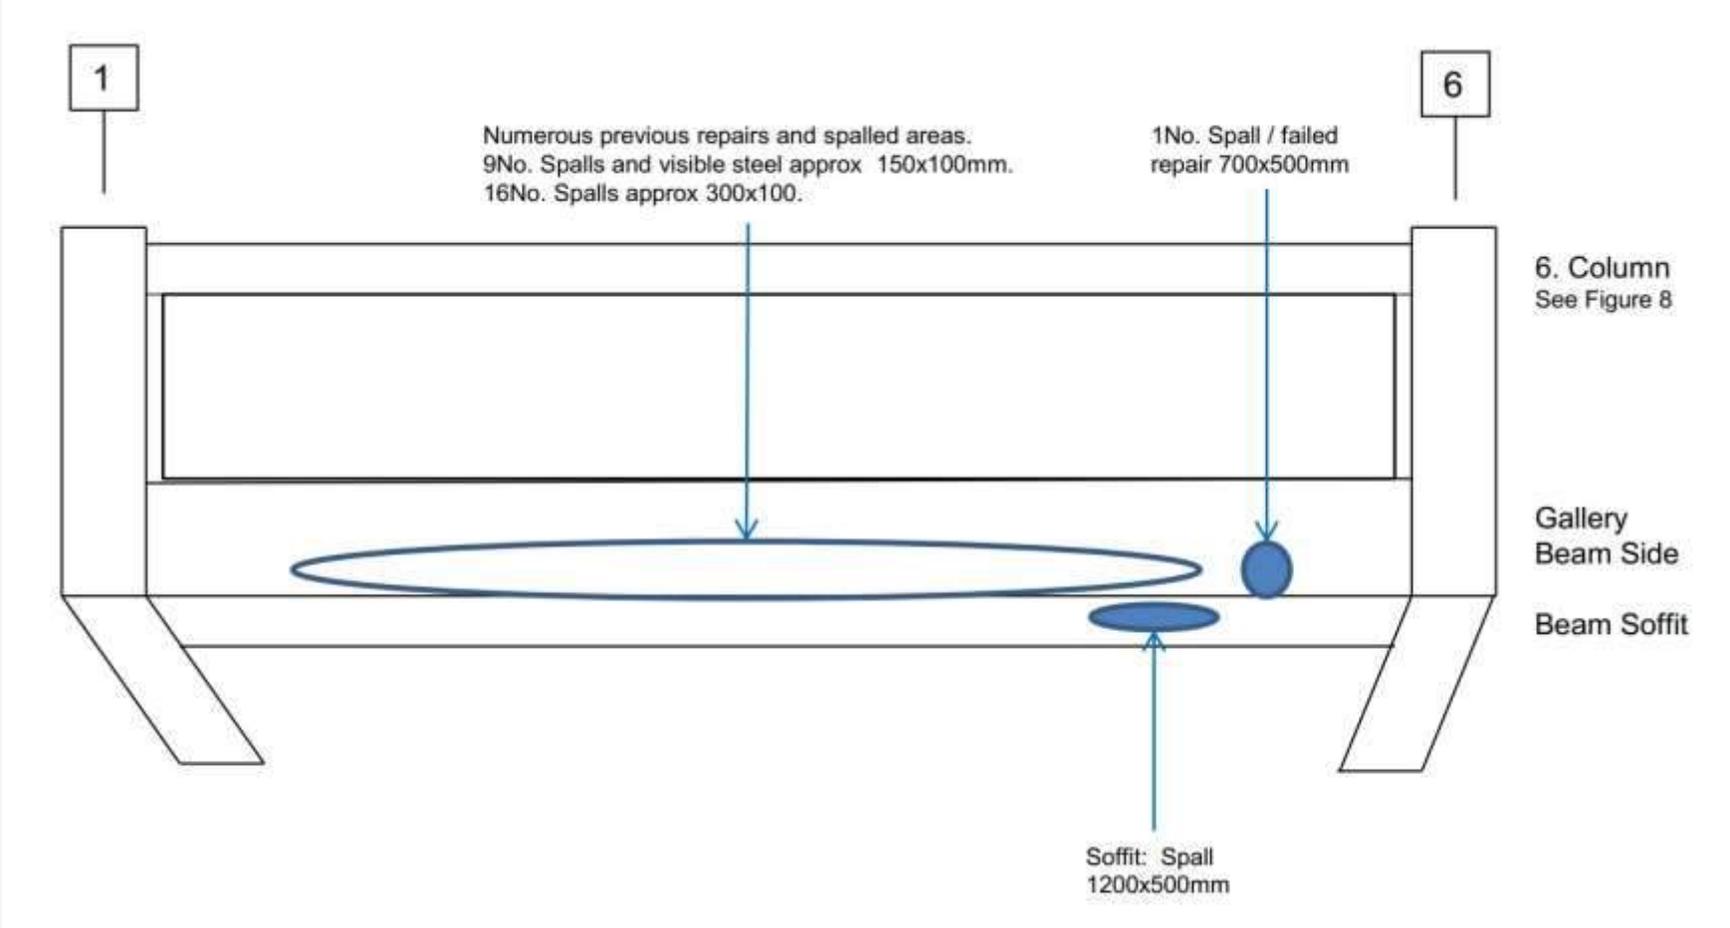
Concrete condition c2011

At several areas, in particular the westerly facing gallery beams, the **cover** to the concrete is very low and the **carbonation** front has caused **steel corrosion** and **spalling** of the concrete. These and other external faces identified will need to undergo some remedial works to restore the appearance of the theatre building and to prevent any further deterioration (2011, Concrete Condition Survey).
